WROUGHT IRON *for* UNDERGROUND SERVICES

A TECHNICAL BULLETIN PREPARED BY THE ENGINEERING SERVICE DEPARTMENT

A. M. BYERS COMPANY • PITTSBURGH, PA.

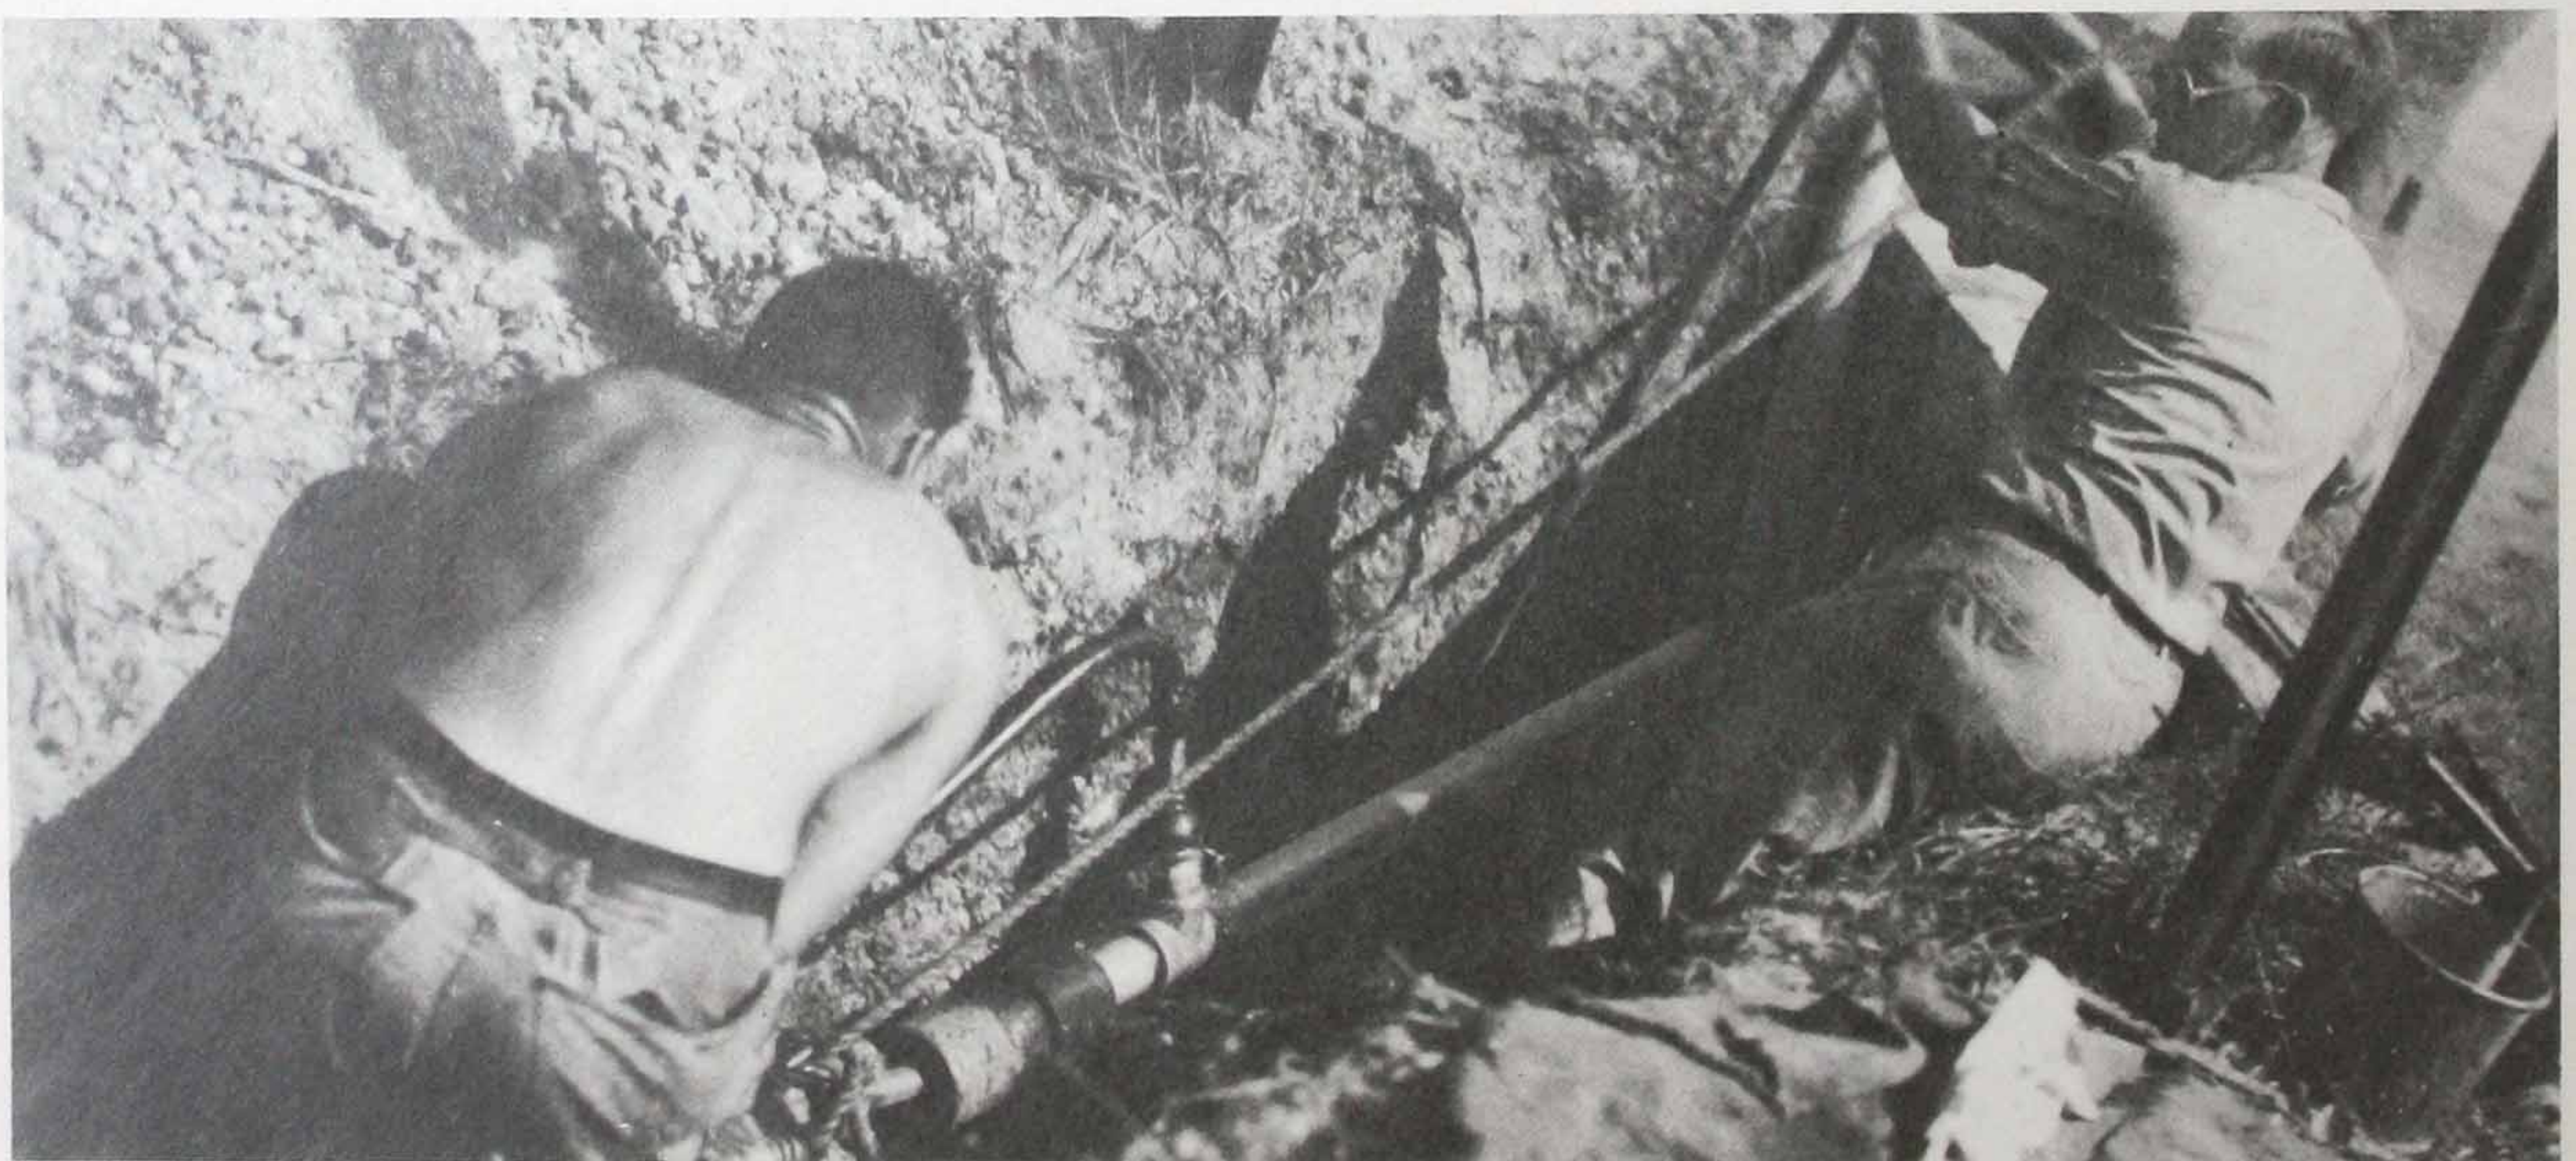
Wrought iron pipe has the rigidity and toughness necessary to permit it to be jacked or driven through the hard-packed soil under roadways. The New Jersey State Highway Department has a standard specification calling for wrought iron for underground cable conduit, and Fig. 56 shows a typical installation being made. Only a short trench was dug at each end of the run of conduit. The intervening section was driven through from one end, using an air hammer.

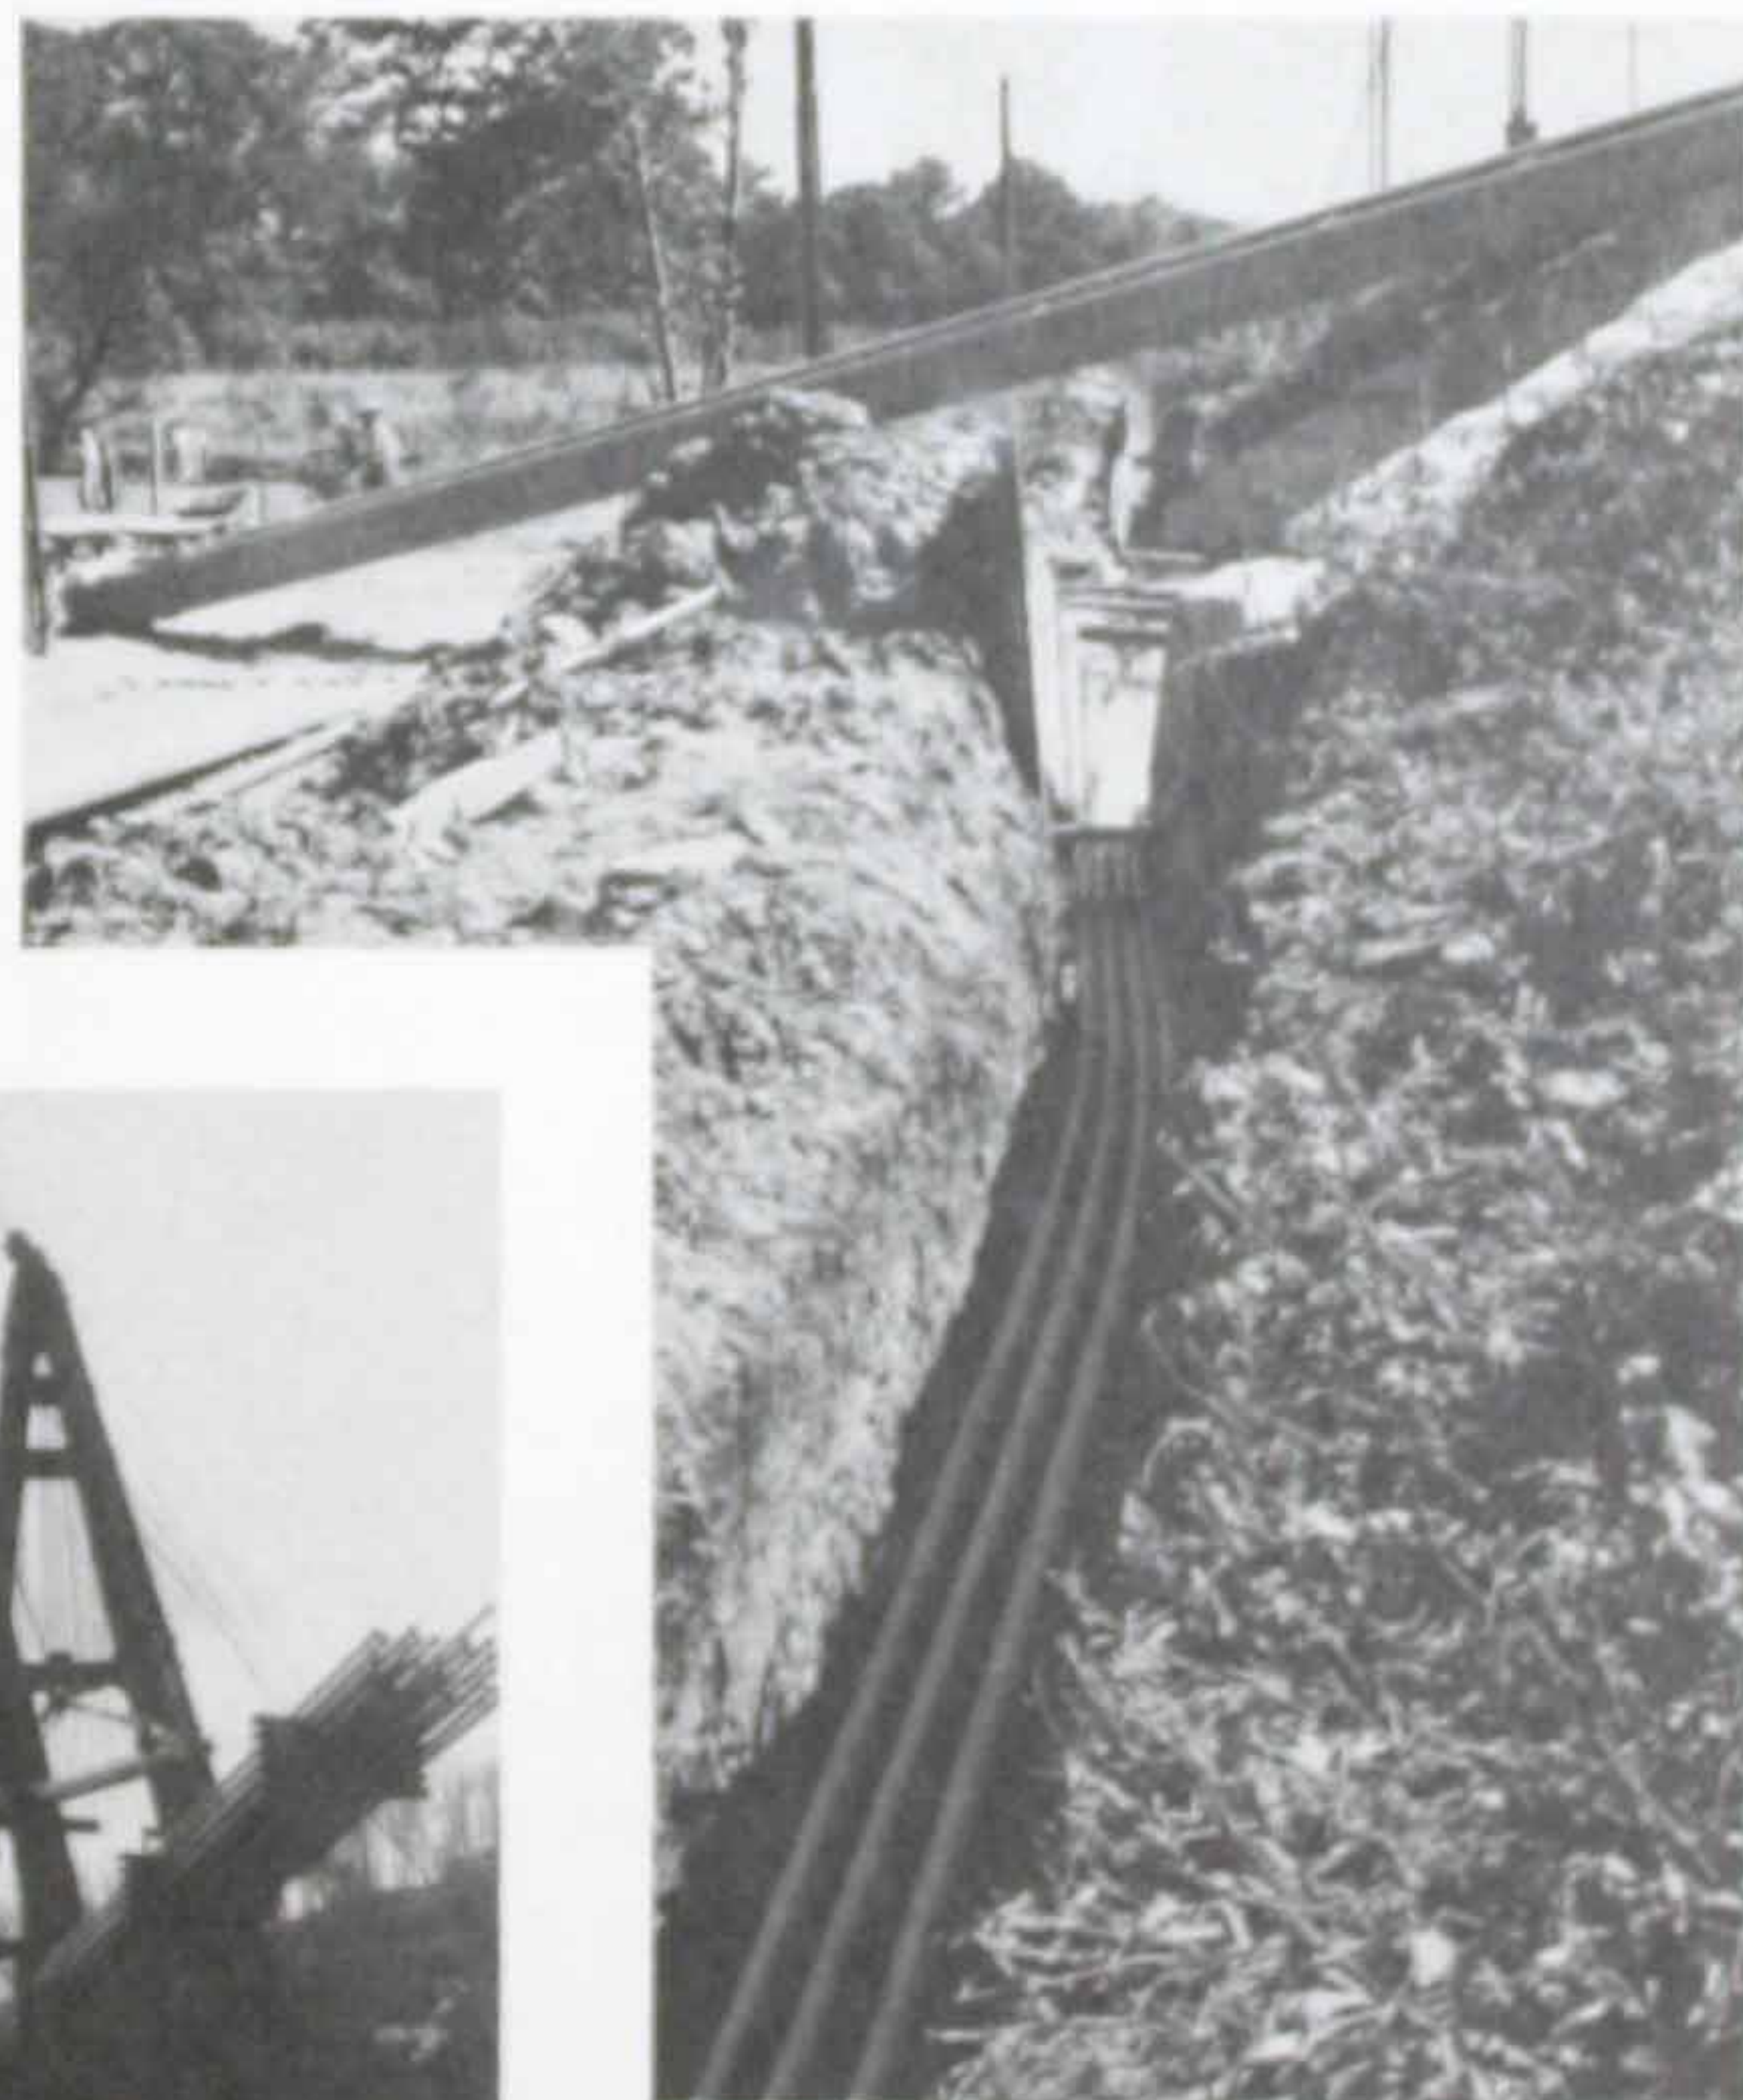
Signal cables paralleling the Pennsylvania Railroad Electrification near Newark, Delaware, are protected by wrought iron conduit where they pass under Christiana Creek. Floods had caused trouble before, so a trench was dug in the creek bed, four lines of 3" extra strong conduit were laid, and cement was poured over the lines. Fig. 60 shows this crossing being installed.

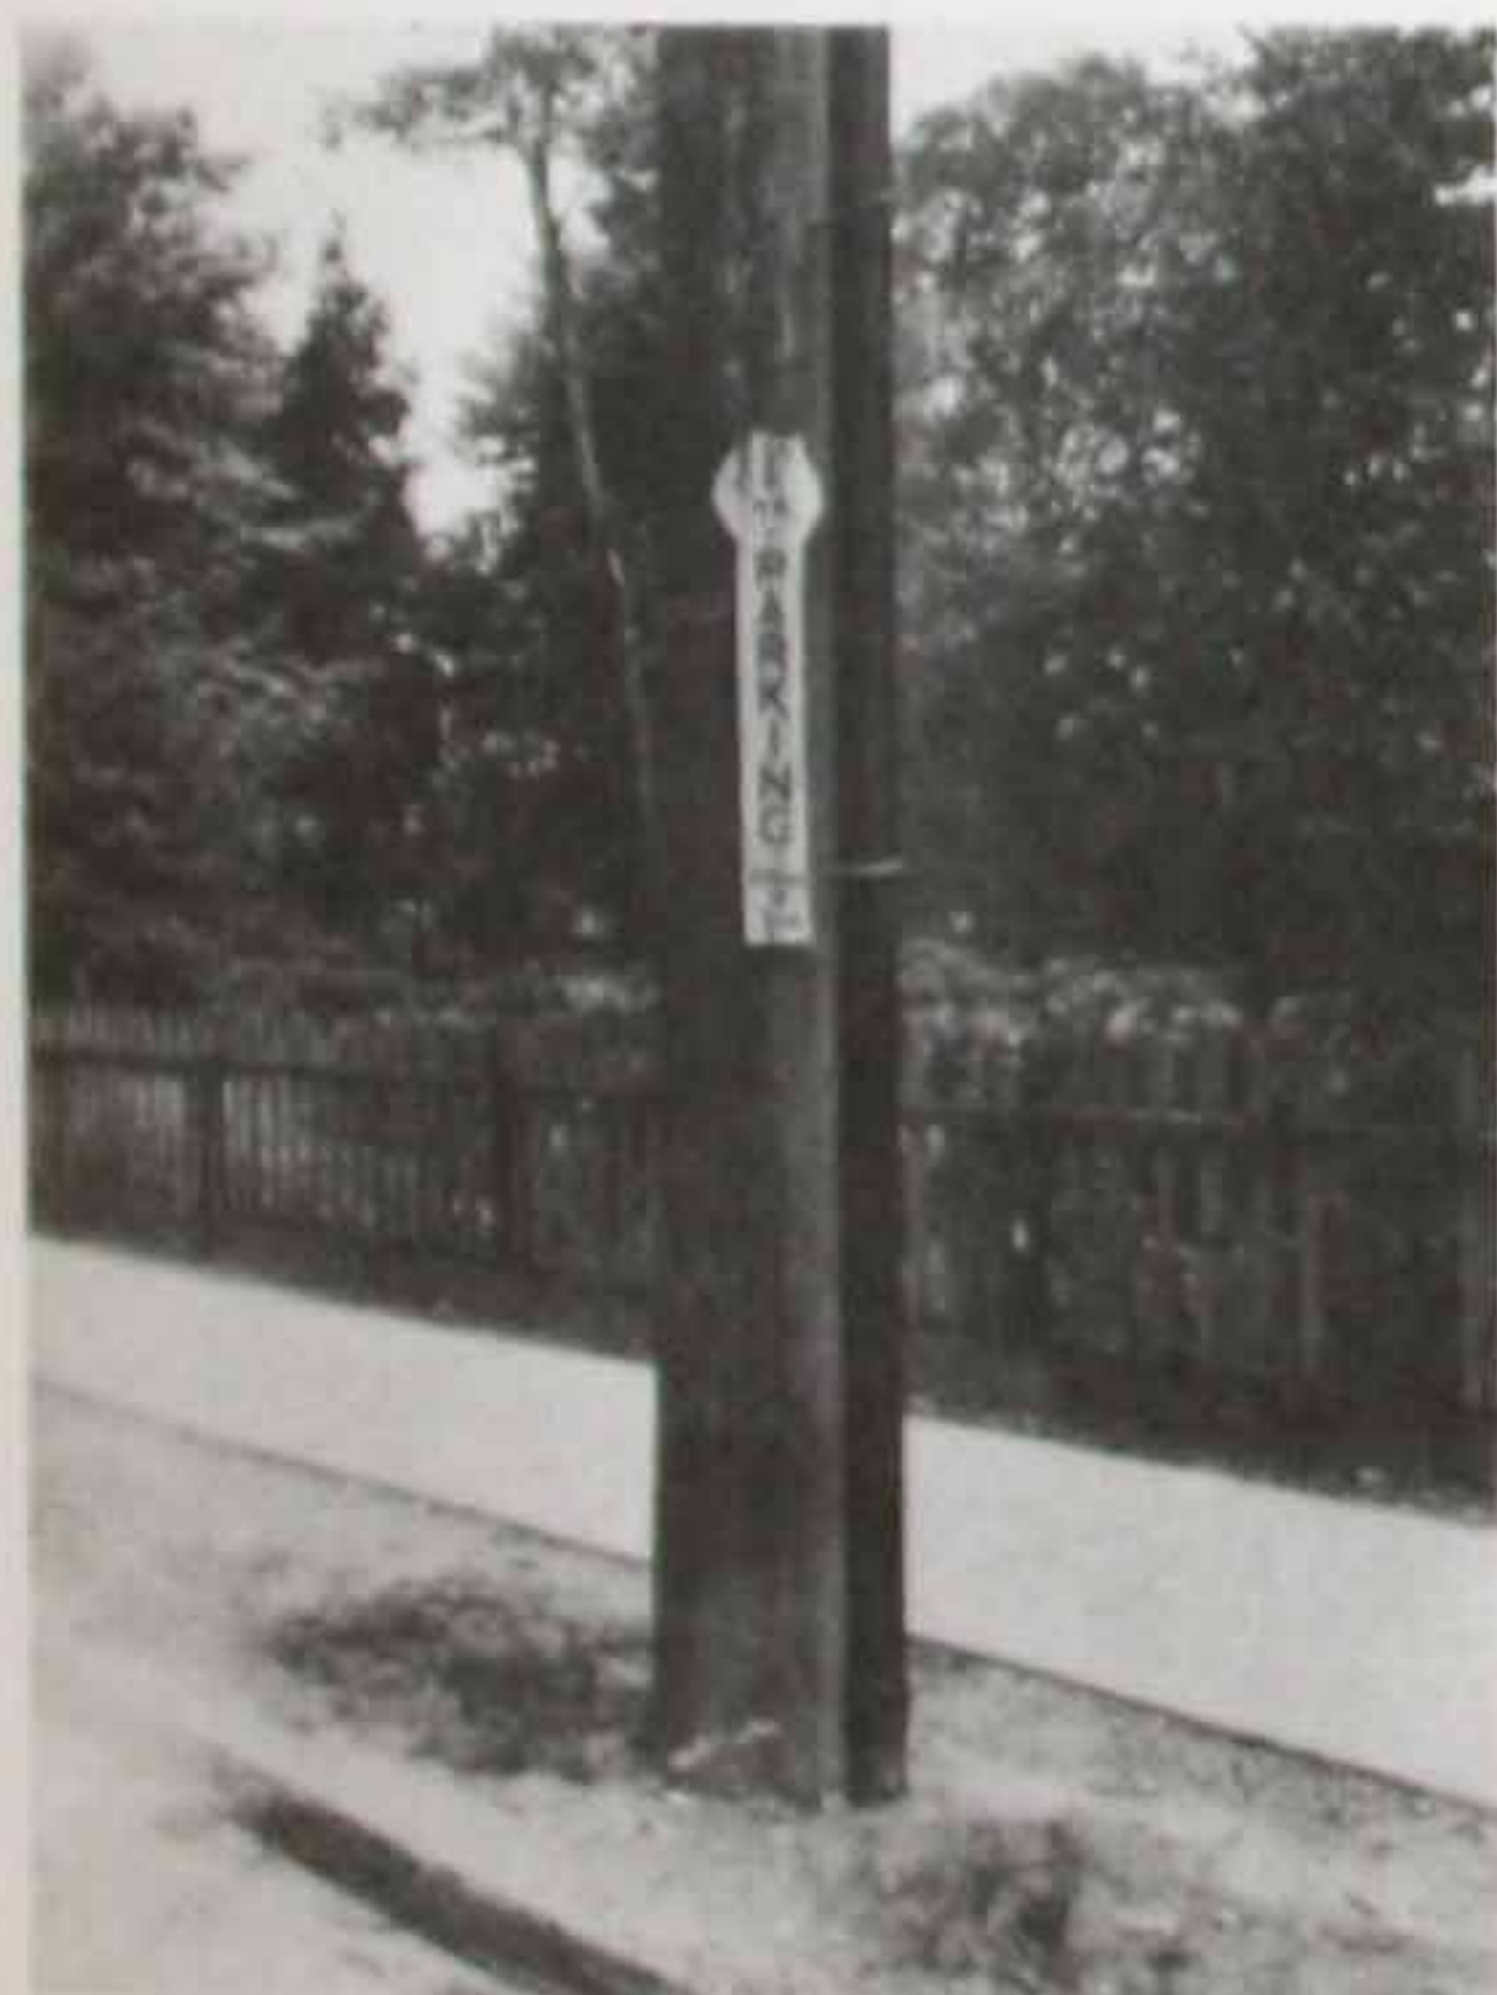
Fig. 57

Chicopee Electric Light Company, Chicopee, Mass., has found that wrought iron lasts longer than other ferrous metals for this service, and one of their installations is shown in Fig. 57.

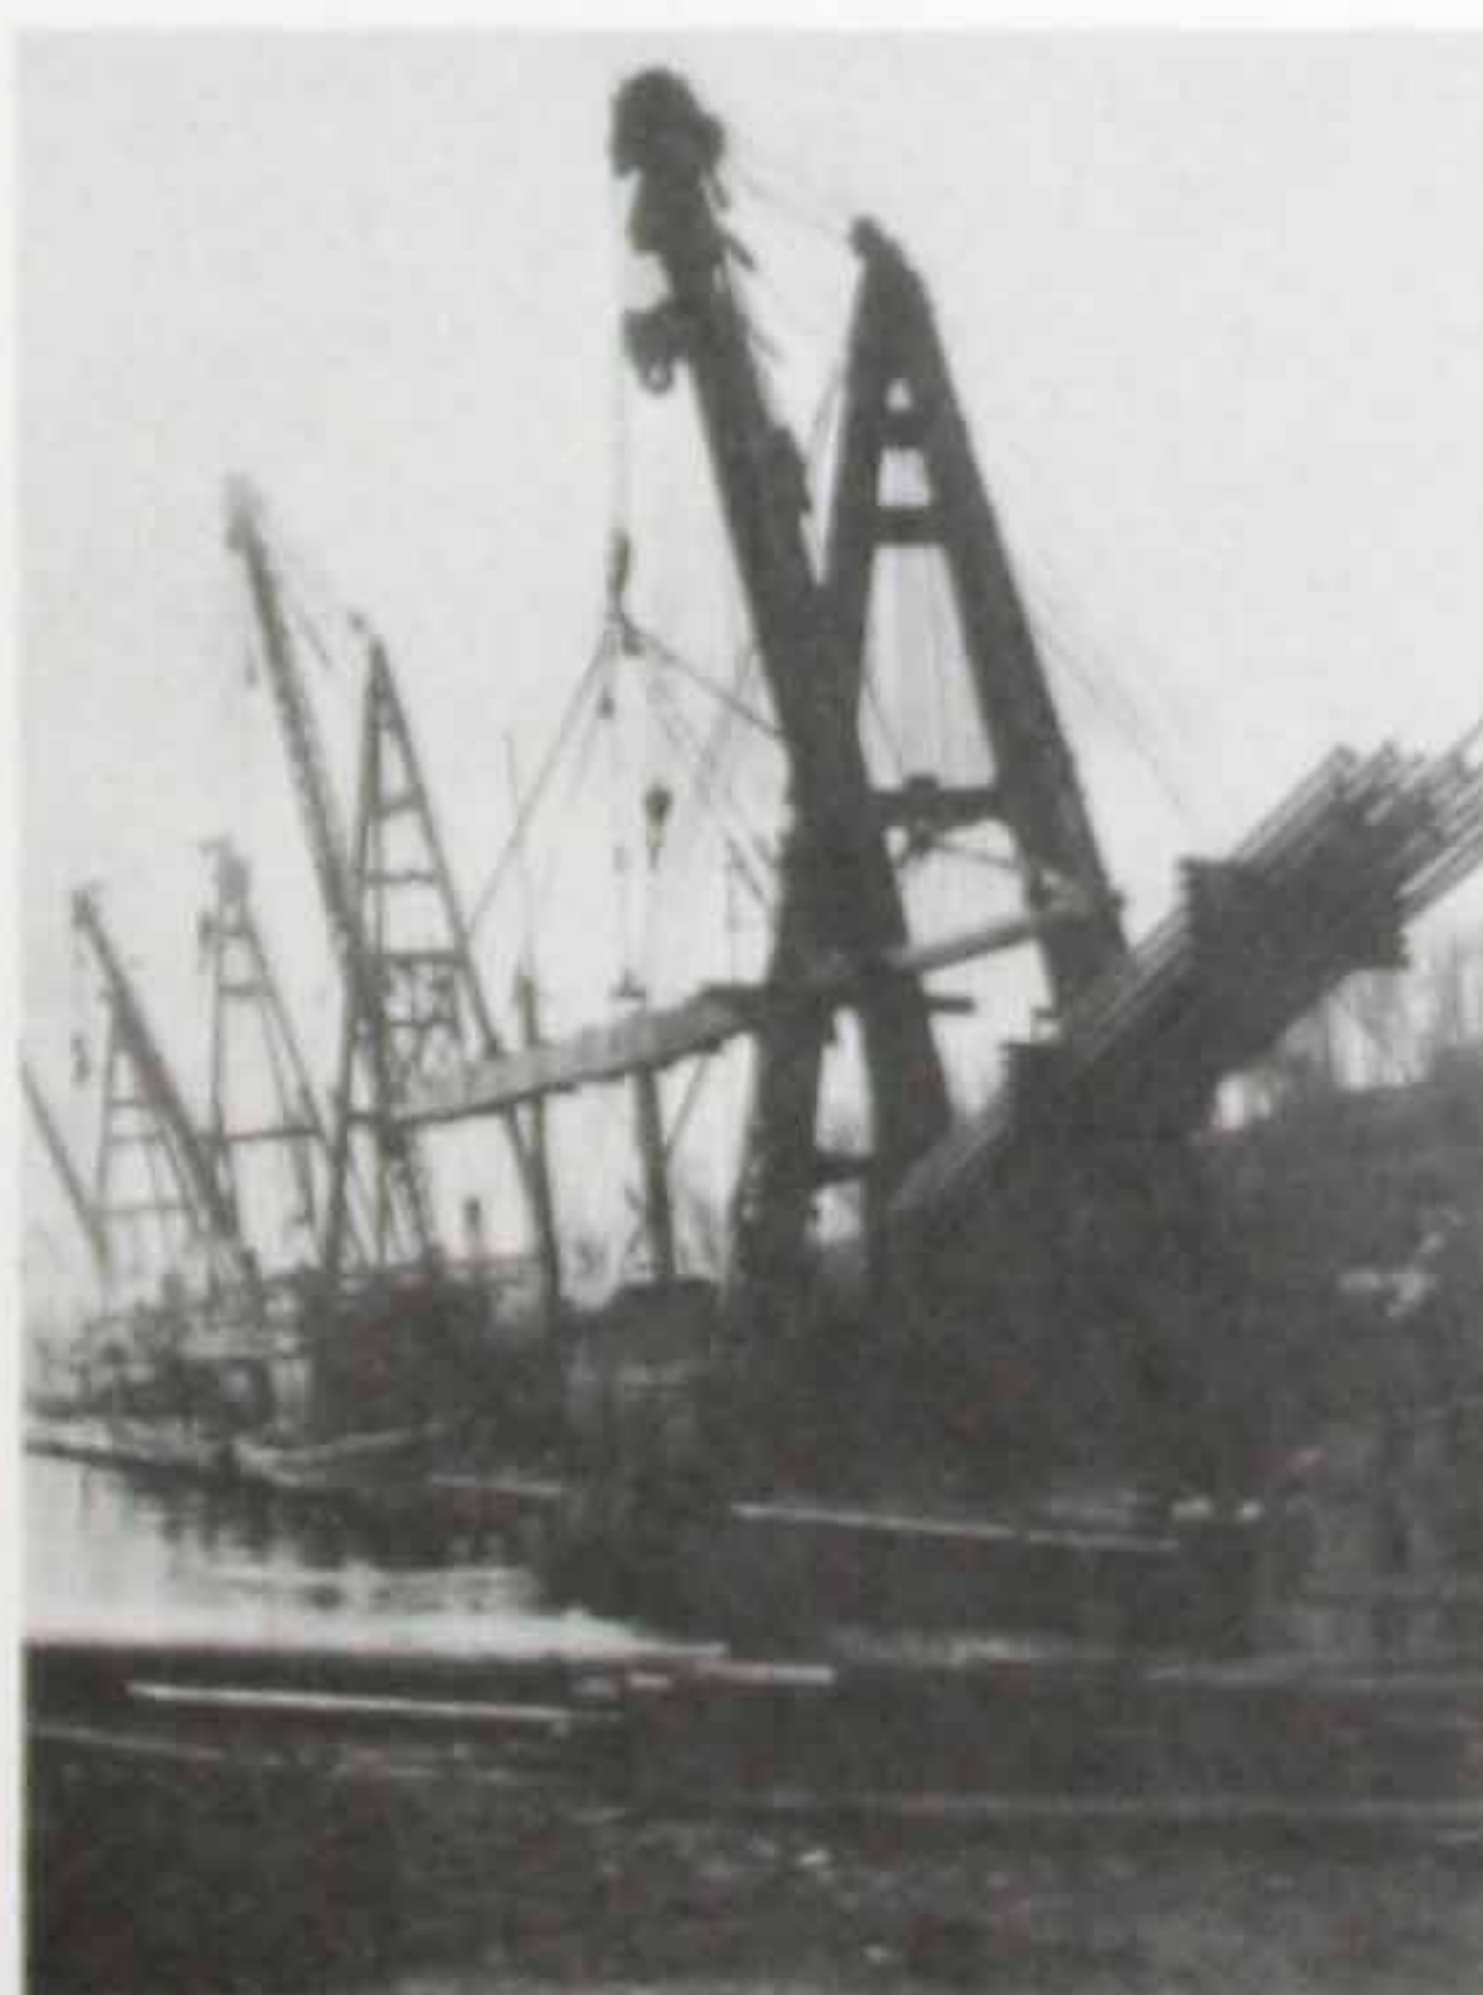
About twelve years ago, the New York Central Railroad was faced with the problem of crossing this stream with the high tension lines to supply the West Side Improvement being constructed by the railroad. Fig. 58 shows the entire group of thirty-six 4" extra heavy wrought iron conduits being lowered into the 32 ft. deep channel. Recent conversations with engineers in the engineering and maintenance departments of the railroad revealed that the installation has been entirely satisfactory.
